Stress-oriented hydrogen-induced cracking (SOHIC) in H₂S environments

ABSTRACT

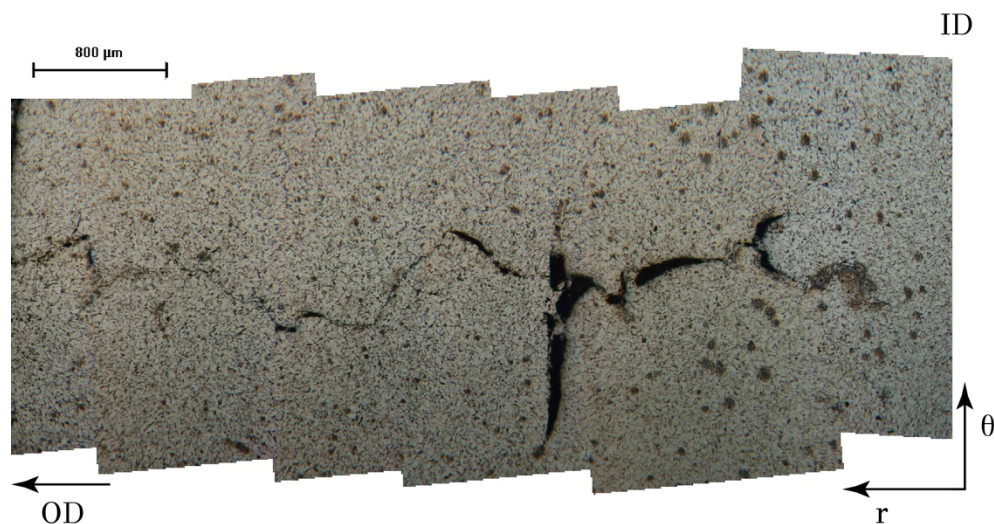
Figure 1: Characteristic crack path during SOHIC

The results indicated that SOHIC proceeds in two steps: (a) initiation of small HIC cracks lying in the rolling plane and stacked in a direction normal to the applied stress, (b) through thickness linking of HIC cracks (see Figure 1). The propagation of the HIC cracks as well as the through-thickness link cracks is associated to cleavage fracture mechanisms.

The key factors identified in this failure were: (a) short periods of high hydrogen charging conditions as manifested by high H₂S/MDEA ratios and (b) stress triaxiality imposed by the relatively large thickness of the plate. The results indicated that a HIC-resistant steel might not be immune from SOHIC. Under high hydrogen charging conditions HIC cracks can initiate at interfaces other than stringer-type inclusions, such as ferrite/pearlite interfaces in the microstructure of the steel.
