## Metallographic assessment of creep in cast tubes of heat resistant steels

Catalytic reforming is routinely used in oil refineries for the production of petroleum byproducts. The process takes place in tubes suspended in a furnace at high temperature. The tubes are fed with hydrocarbon and steam mixture in the presence of a catalyst. The reforming reaction takes place at a high temperature of the order of 900°C. The high pressure in the tubes generates stresses causing creep of the tube material. The reformer furnace tubes are centrifugally cast and are manufactured from heat-resistant alloys, containing Ni and Cr. The heat resistant steel investigated in this study is a Nb-stabilized grade. The effect of Nb is to precipitate Nb<sub>4</sub>C<sub>3</sub>, which increases creep resistance and rupture strength. In the present investigation, tubes were removed from reformer furnaces after certain fractions of operation times and also after thermal shock events. Creep damage was assessed by metallographic techniques. Aging of the microstructure was quantified, as ductility reduction, by room temperature mechanical testing. The results indicate that aging is taking place progressively

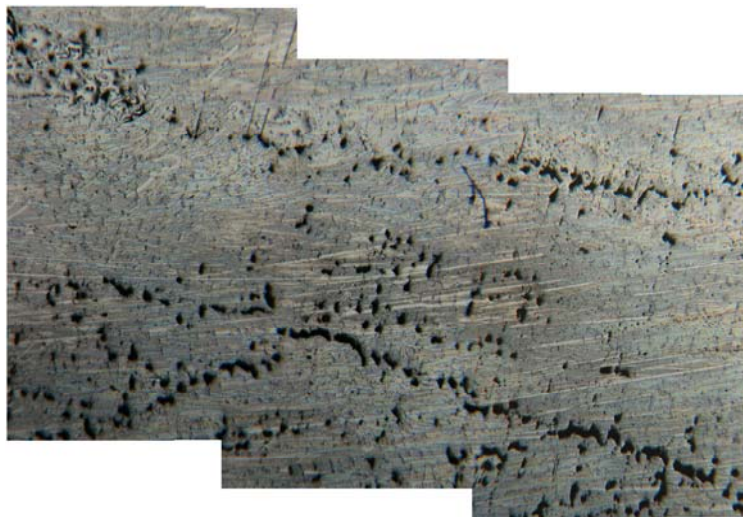
Figure 1: Advanced creep damage in the form of chains of cavities

Creep damage has been classified according to VGB standard [2]. All creep categories have been observed: isolated cavities, dense cavities, oriented cavities (Fig.1) and advanced creep damage with the formation of grain boundary microcracks, which evolve as major cracks across the tube thickness.
